Temperature Based Condition Monitoring of Rail and Structural Mill

Lakhan Patidar, Chitragupt Swaroop Chitransh, K.U. Rao

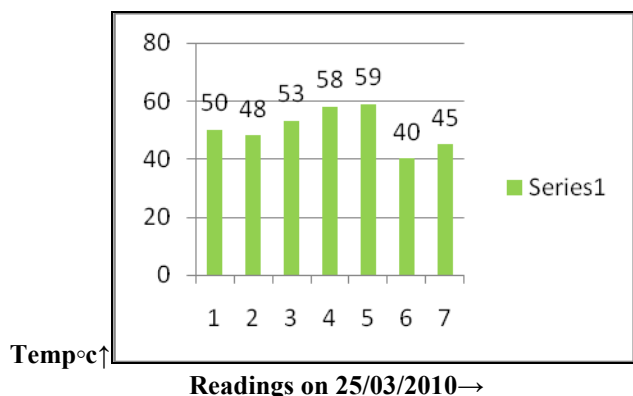
Graph4.)

Above graph shows that all readings are in normal range taken on 25/03/2010. It shows that no maintenance work is needed at this stage. With the help of 'hot spots' we can easily find out excessive temperature at a particular point.
